Status of the PFC Assessment/Remediation Projects in Minnesota

Presented to: MPCA
St. Paul, MN

Presented by: 3M Company

Date: July 23, 2013

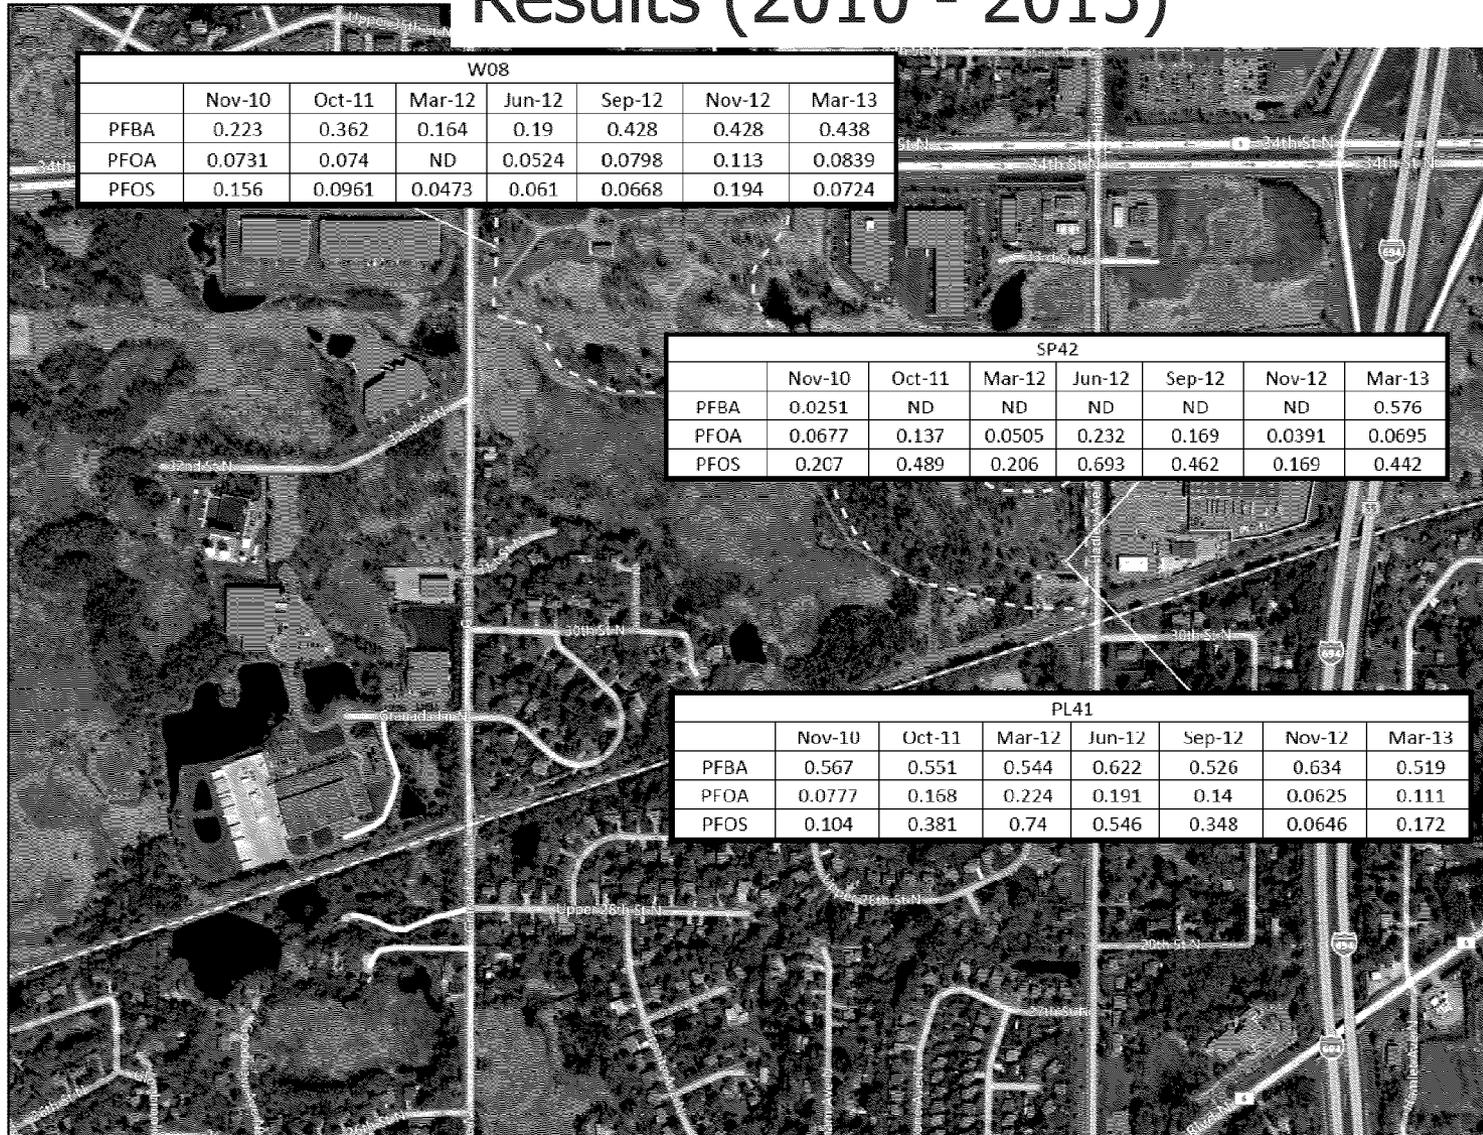
Notes:
-All sample results reported in parts per billion (ng/g)

PFBA, PFOA, and PFOS
Concentrations Detected in
Groundwater

Oakdale Site
Oakdale, Minnesota

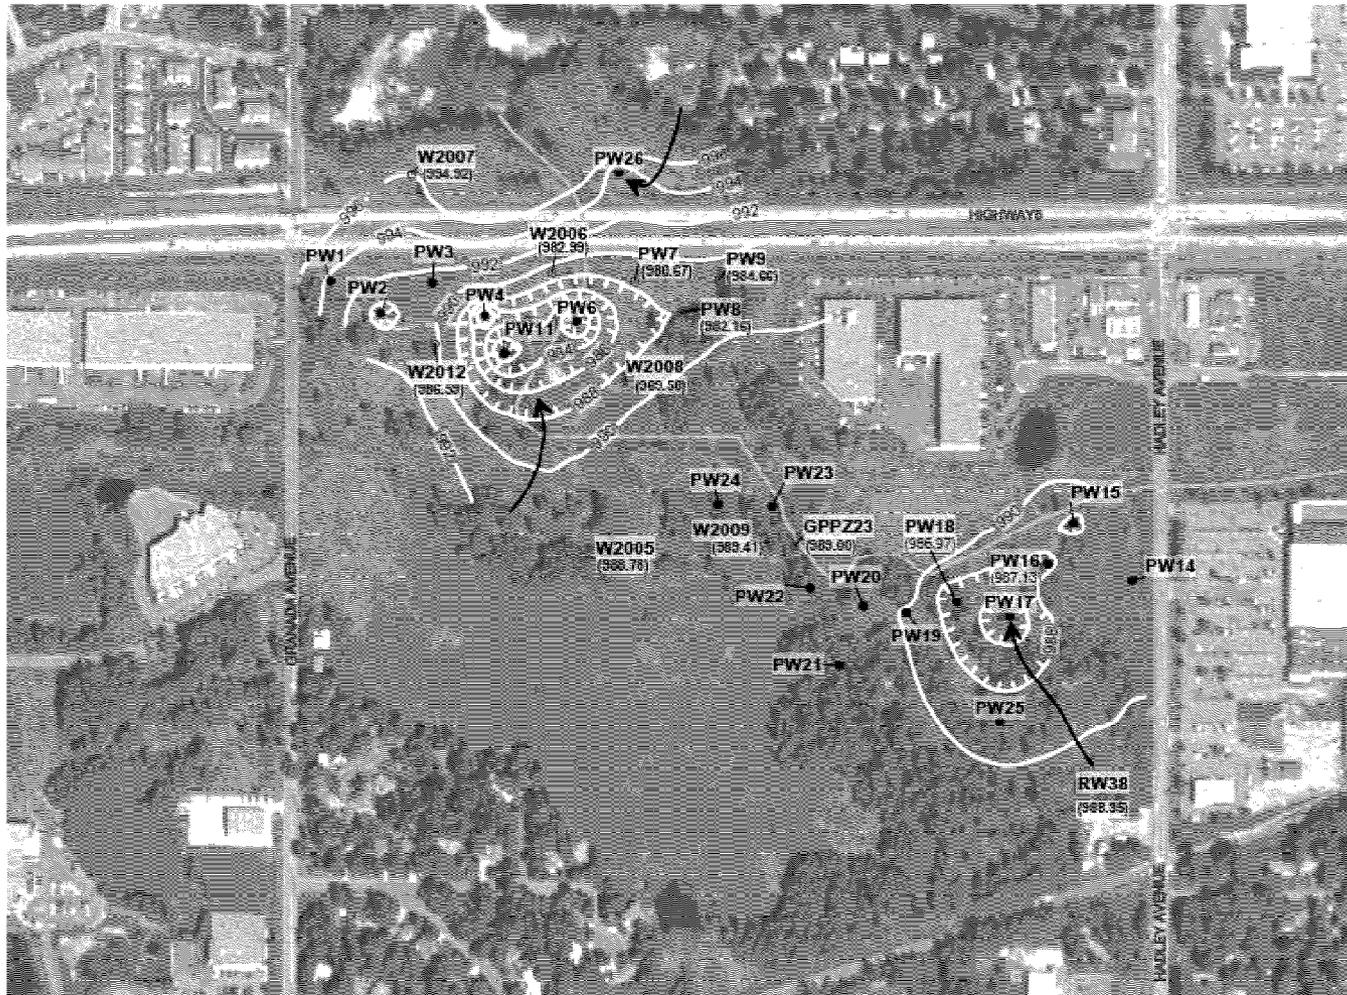
Groundwater Elevation Contour Map
Lower Alluvium Aquifer
24 January 2013 - 1st Quarter

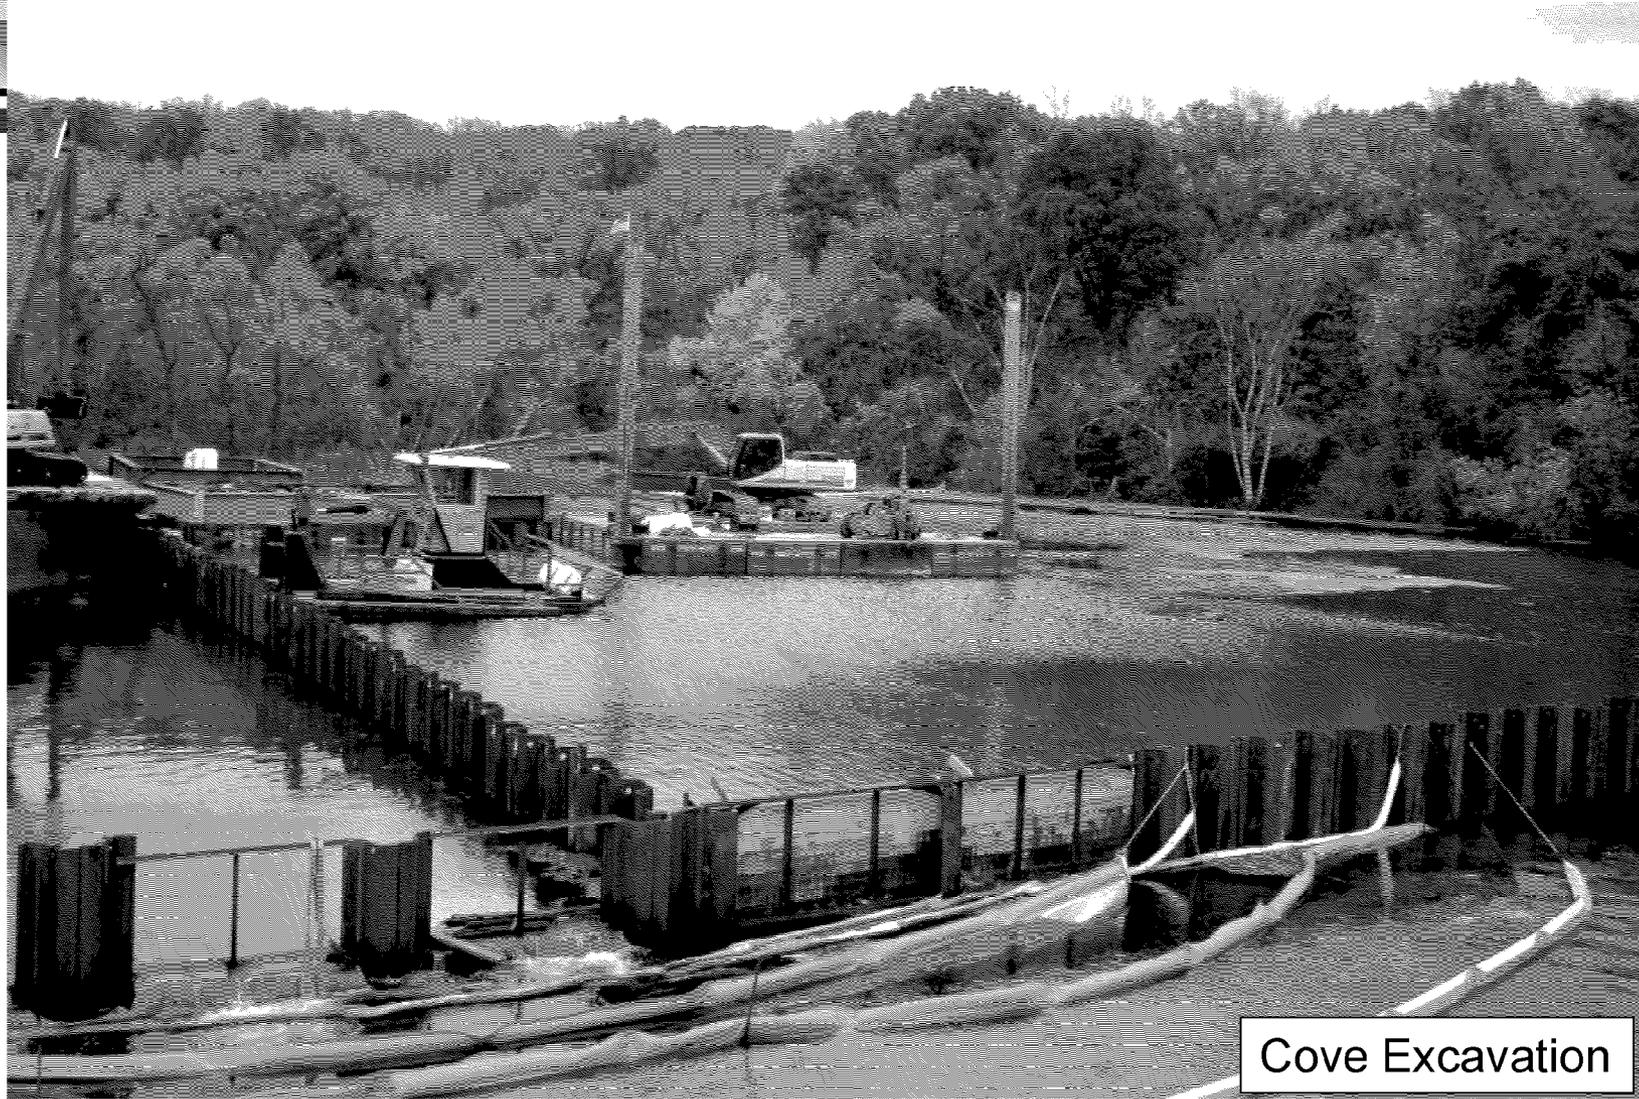
East Cove Sediment Removal

Cove Excavation

- All construction activities are complete; CCR for excavation and backfilling was approved by MPCA in 2012.
- Report on initial planting submitted to MPCA on December 19th, 2012; a similar report was submitted to the USACOE and the MDNR, per the requirements of the permits/approvals from the agency

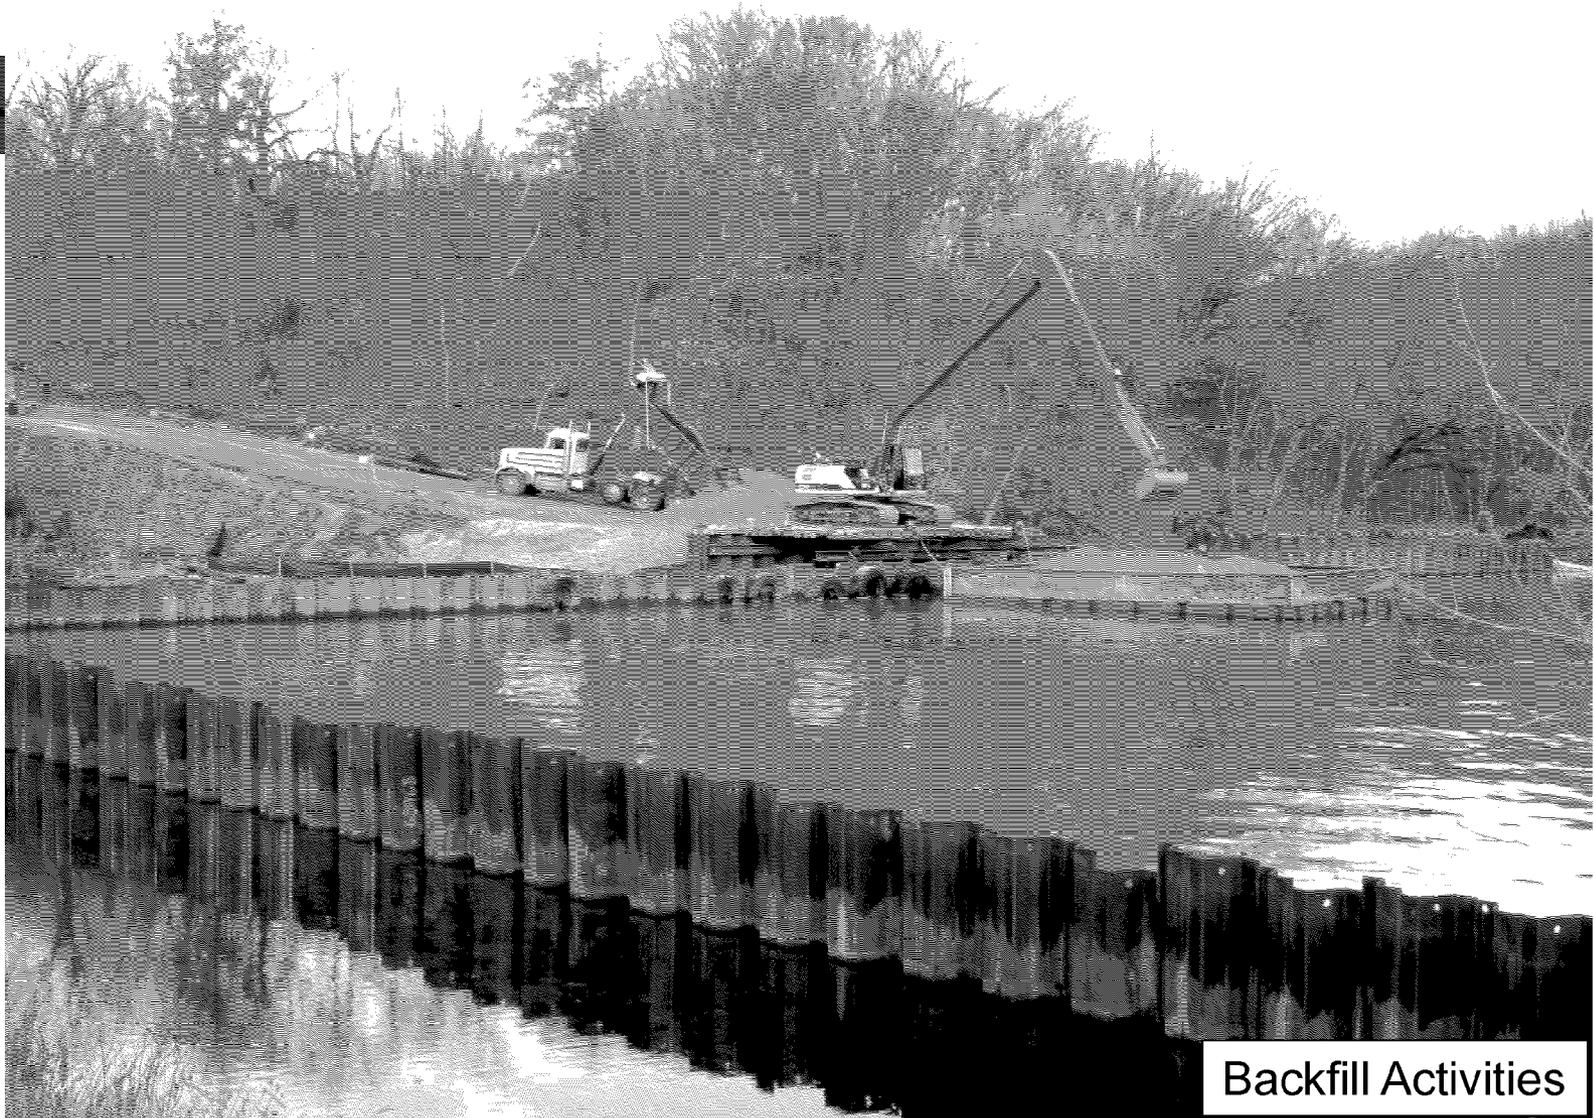
East Cove Sediment Removal

Backfill Activities

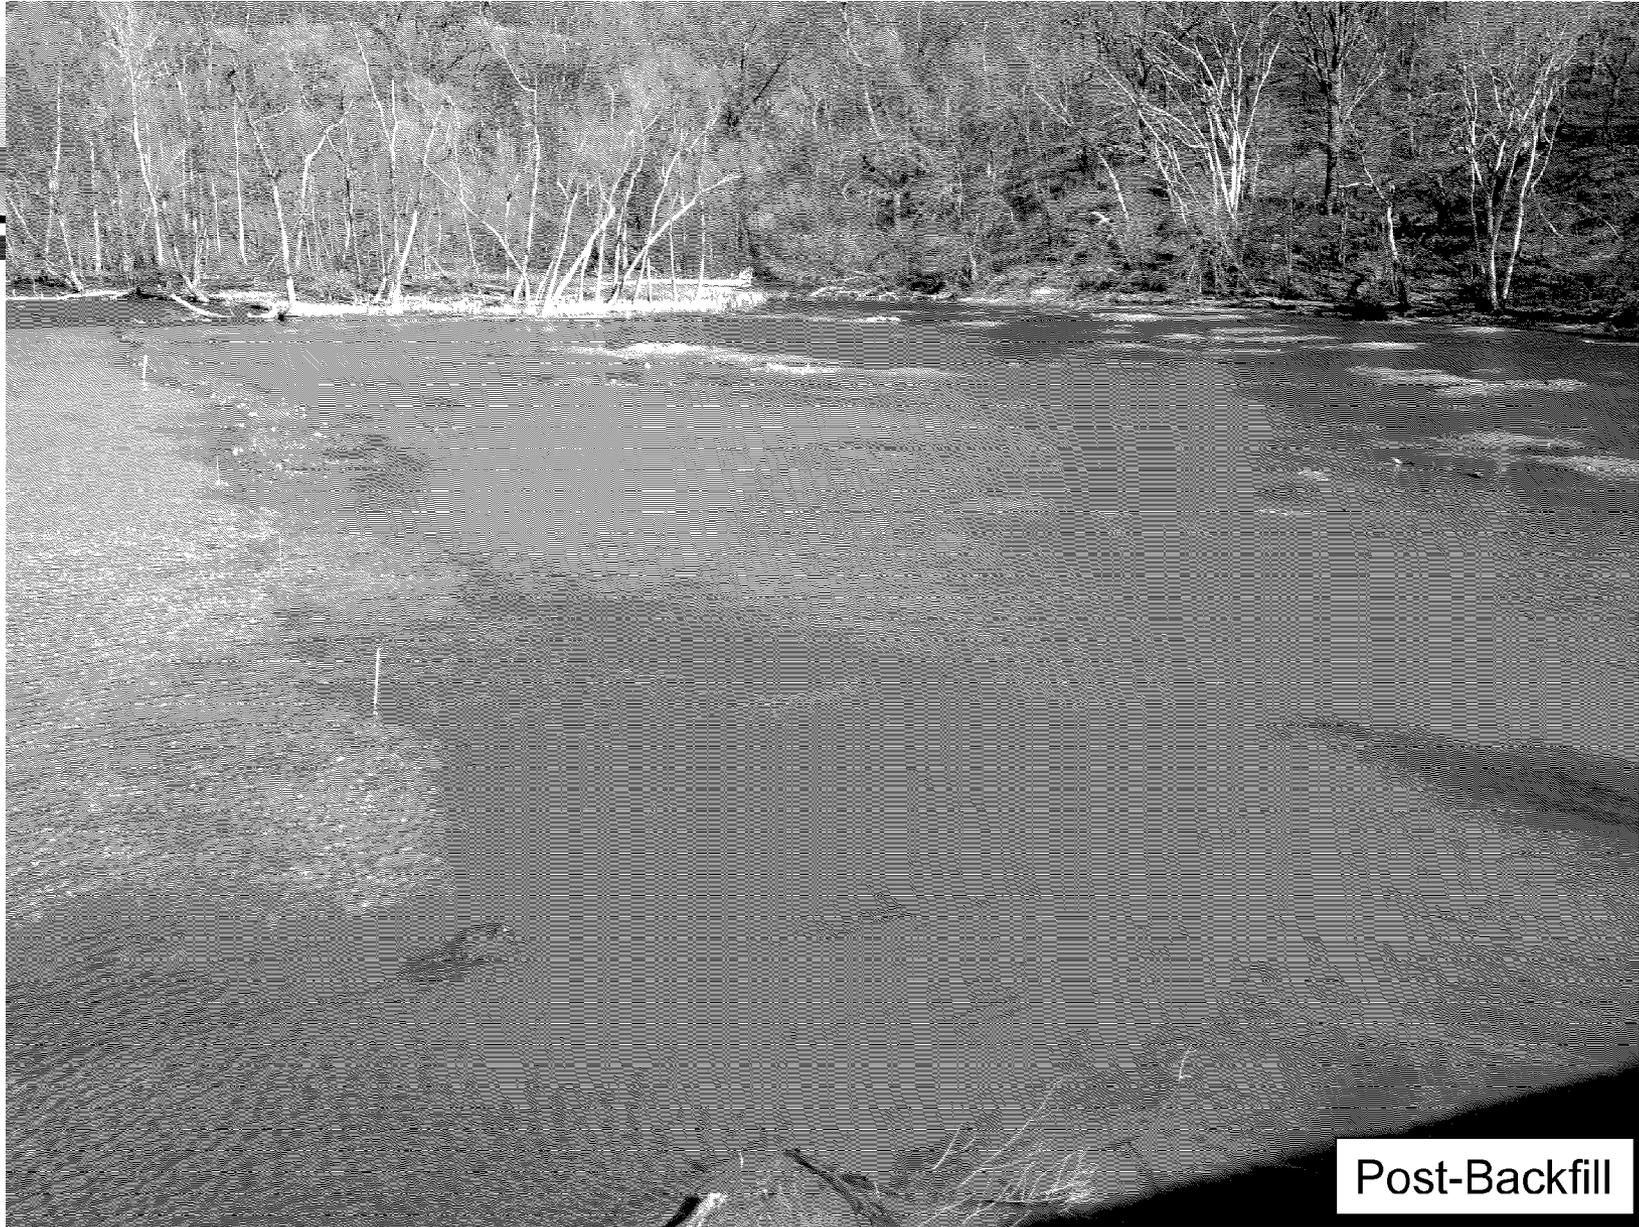
East Cove Sediment Removal

Post-Backfill

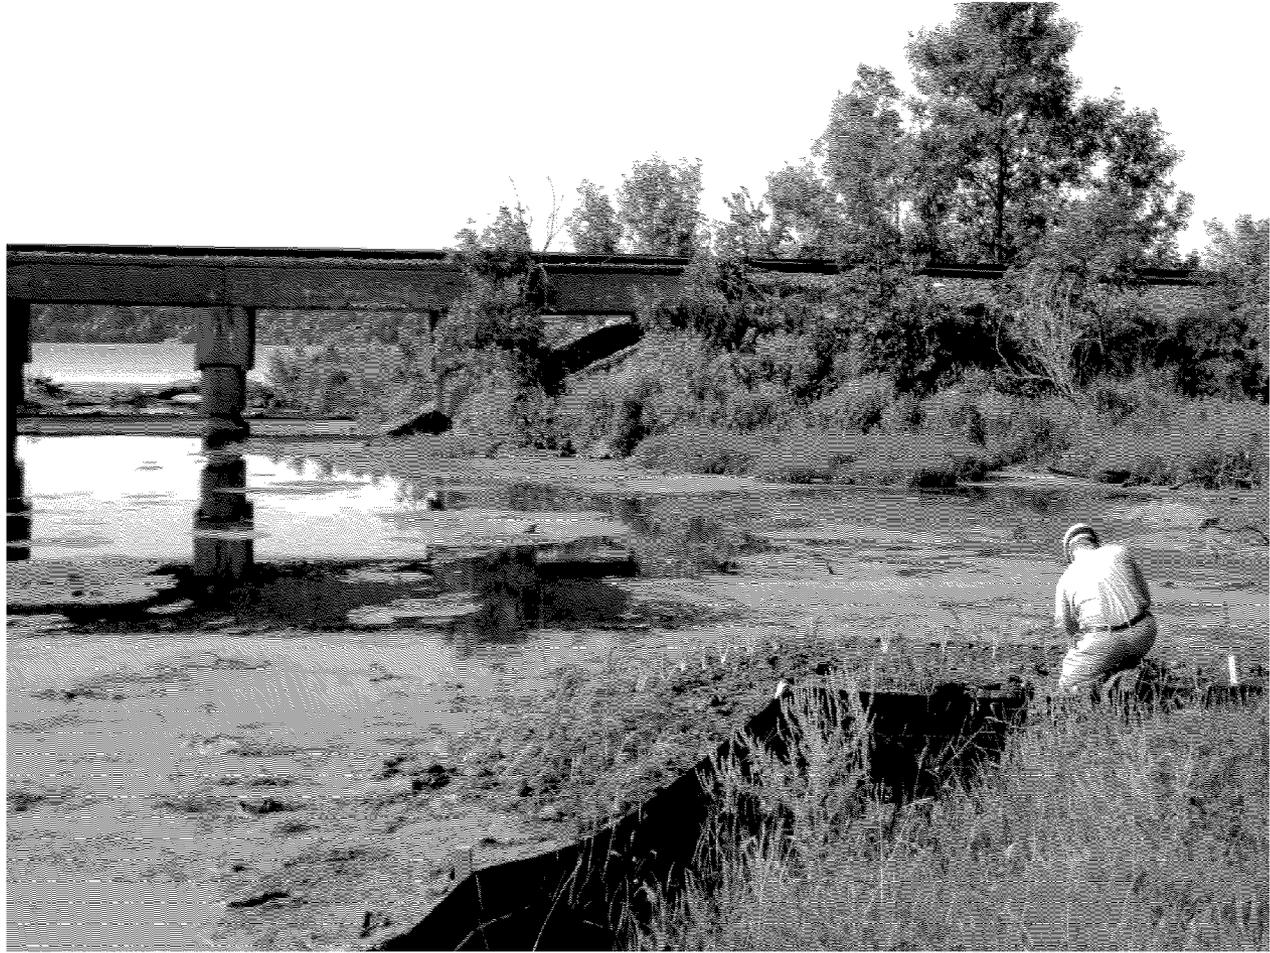
East Cove Restoration

Planting
Activities –
Western Edge of
Main Flow
Channel
(Looking South)

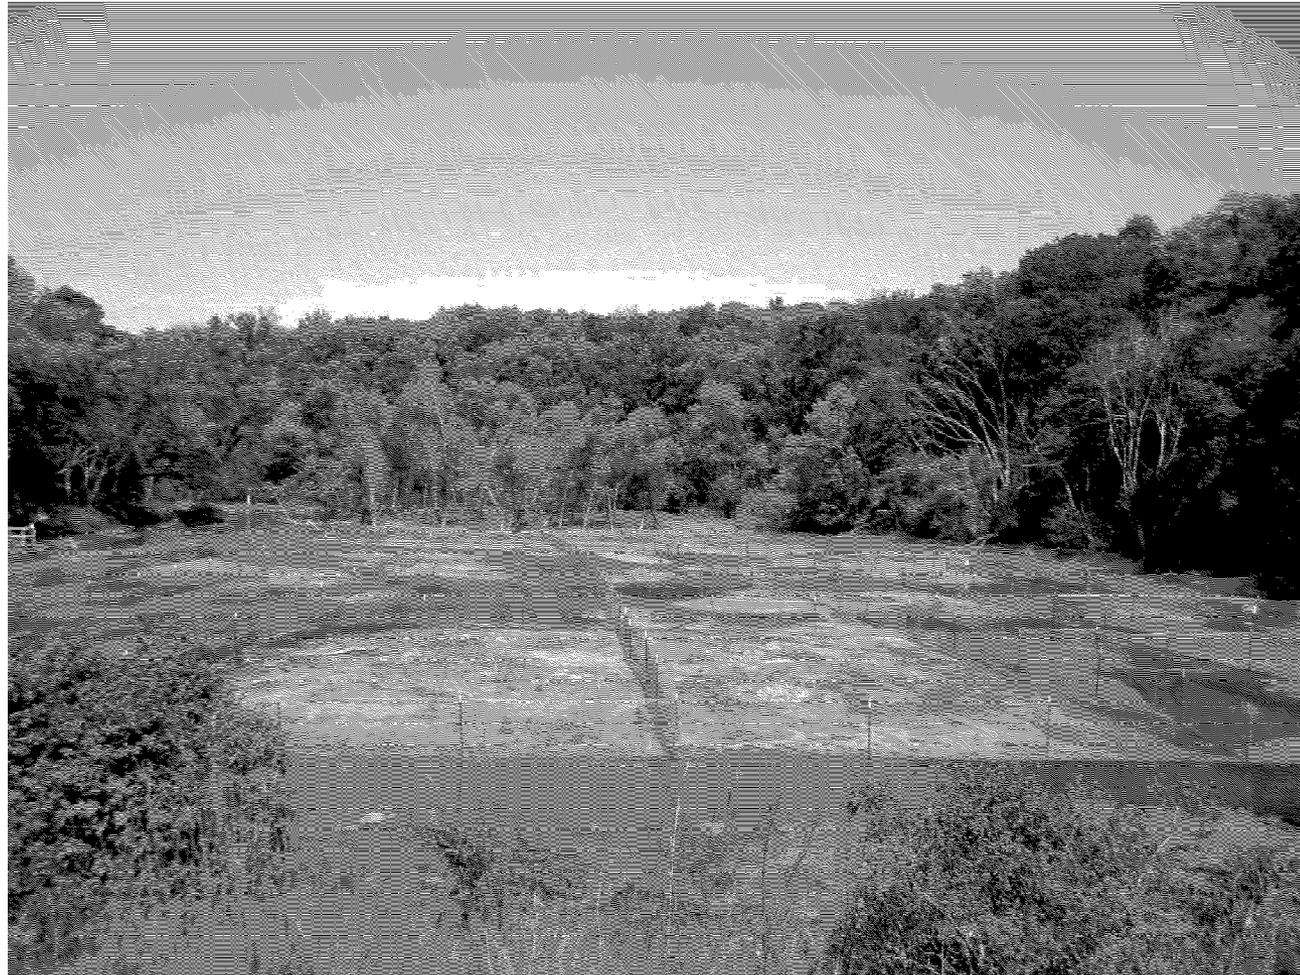
East Cove Restoration

Overview of East
Cove
(Looking North)

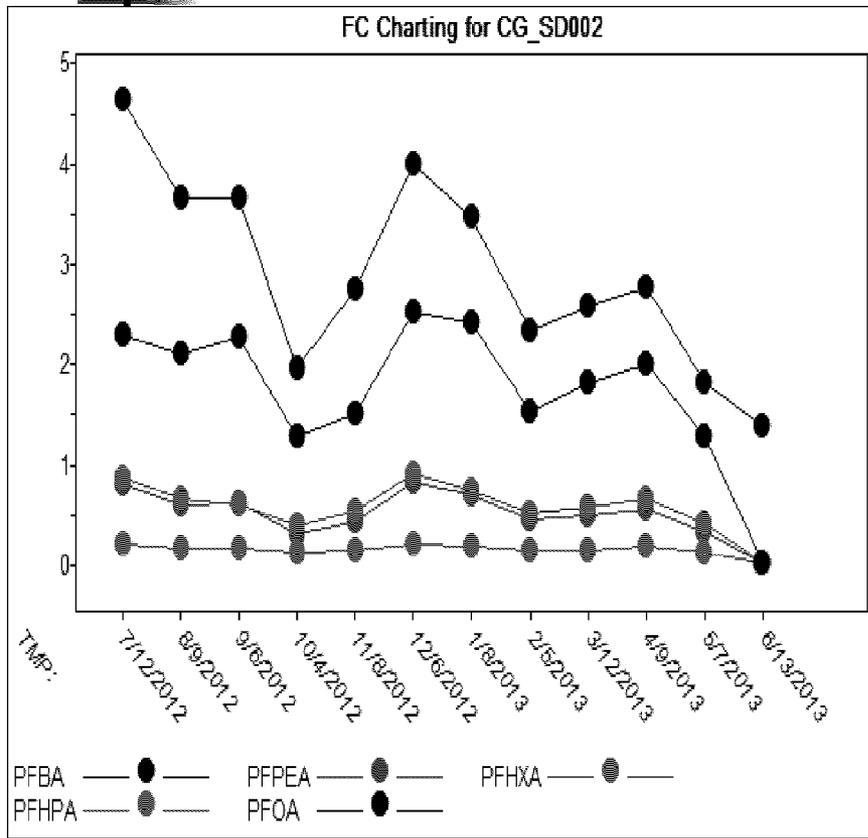
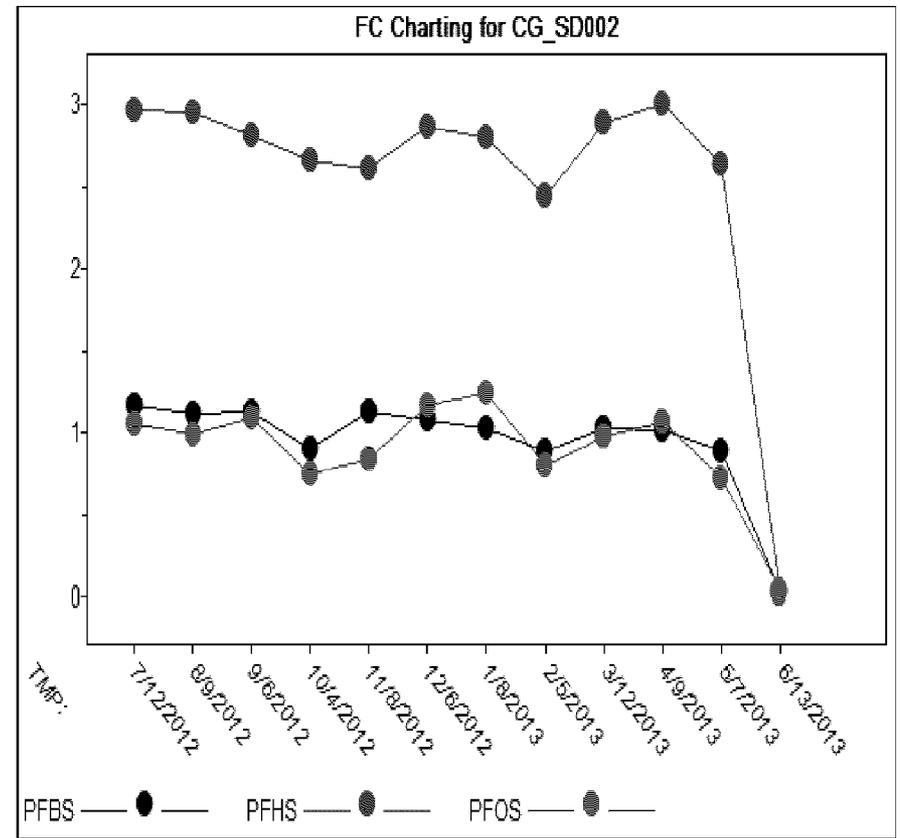
Outfall SD002 Results

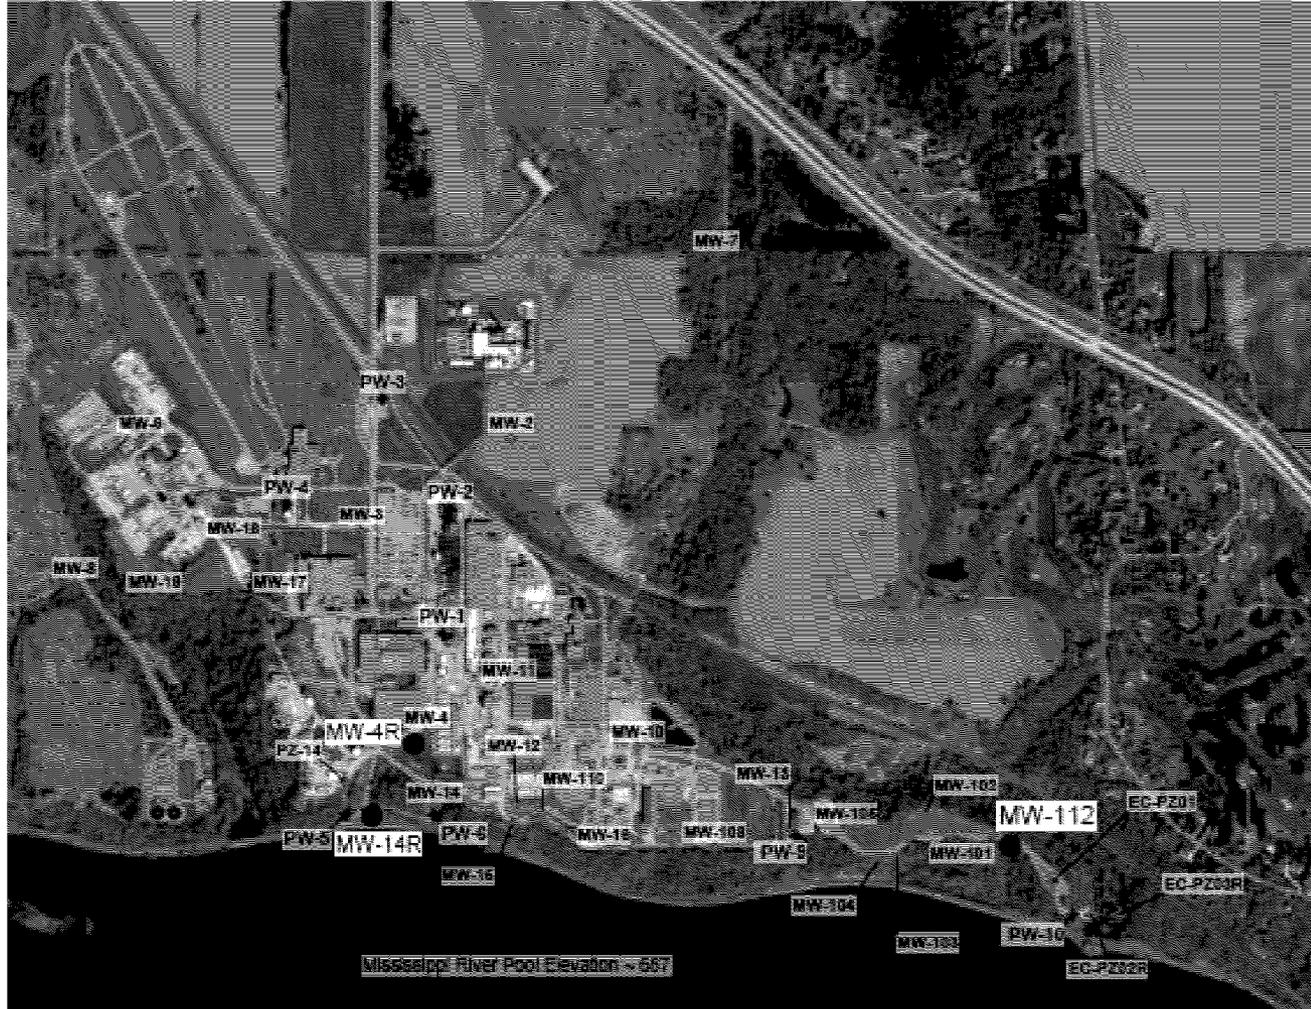
Cottage Grove New Monitoring Well Locations

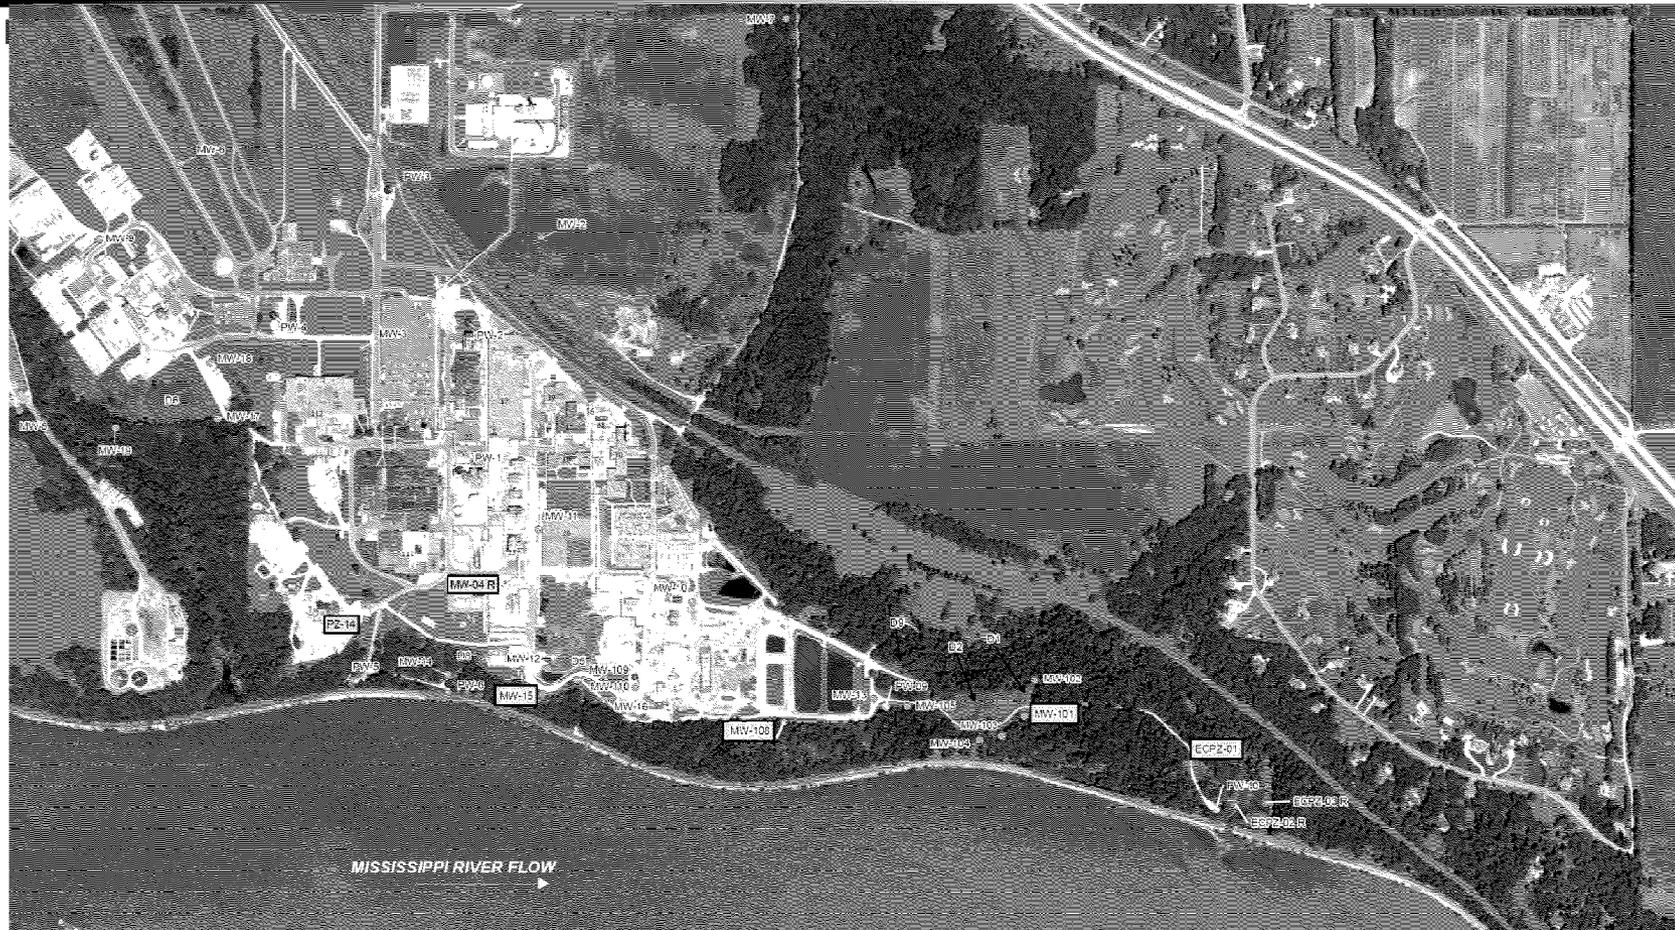
Cottage Grove Groundwater Hydrograph Locations

- 2/18/2013 – Began pumping- 250 gpm each well. Flow rates periodically adjusted and water levels measured
- Providing monthly updates to MPCA and MDH
- Groundwater elevations have risen significantly in background wells (> 10 feet over last couple of months).
- Pump test is on-going and data continues to be collected and assessed.

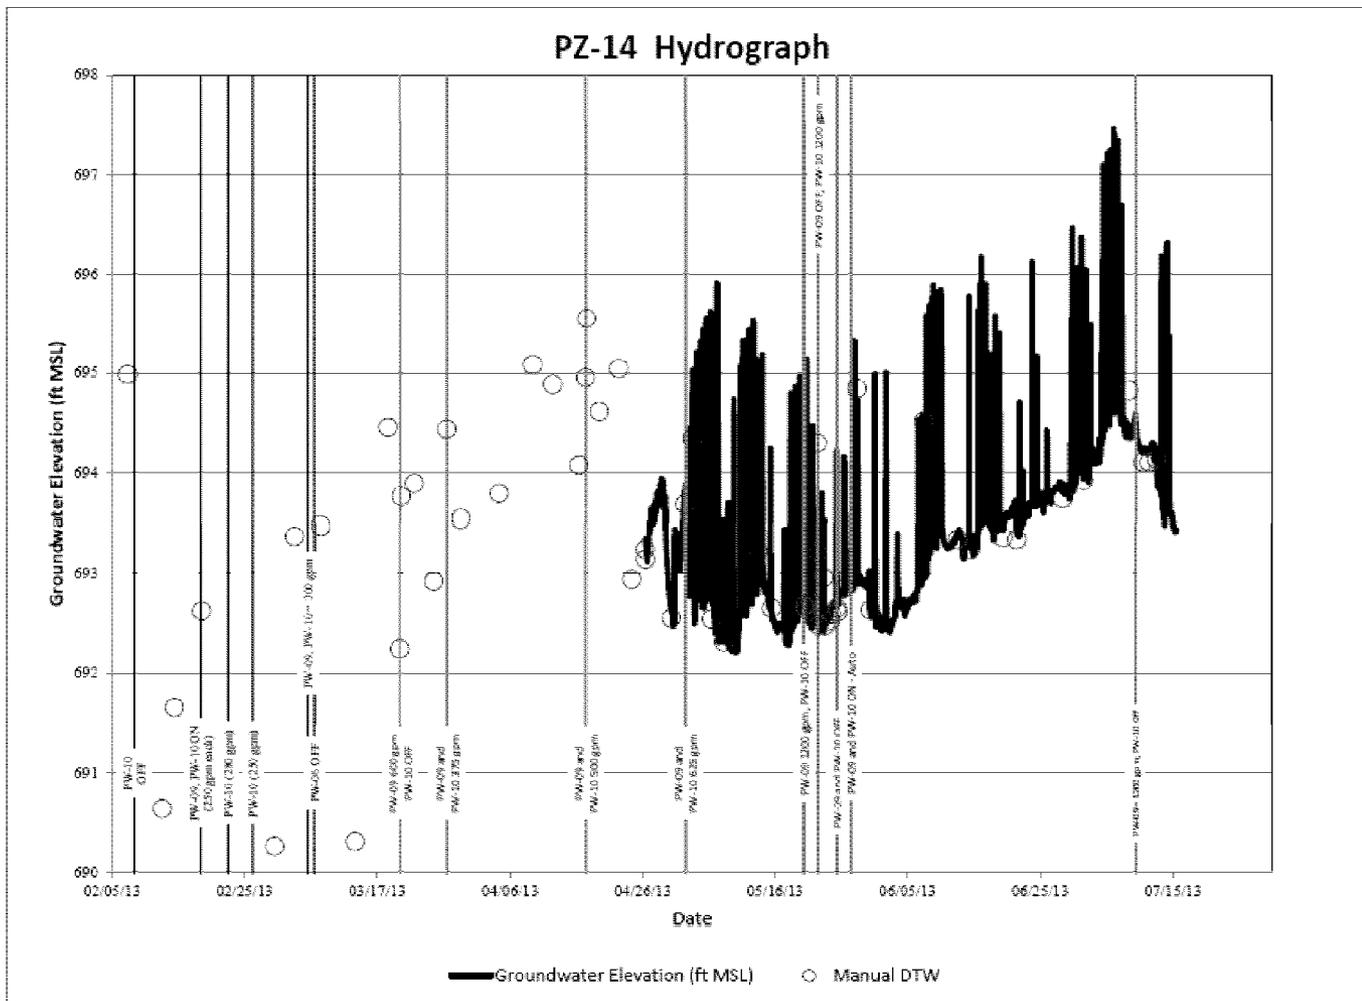
Cottage Grove Groundwater PZ-14 Hydrograph

- PW- 9 and PW-10 can each sustain a maximum flow rate of 1,200 gallons per minute (gpm).
- Pumping rates of wells are being varied periodically and water levels in monitoring wells are being regularly monitored.
- Water levels are still showing downward trends, even after pumping the two wells for two weeks.
- Preliminary analytical data show that influent levels of PFOA and PFOS each remain < 0.5 ppb.
- The Woodbury site system flow rate has stabilized at approximately 2,700 gpm after connection to the GWTP.

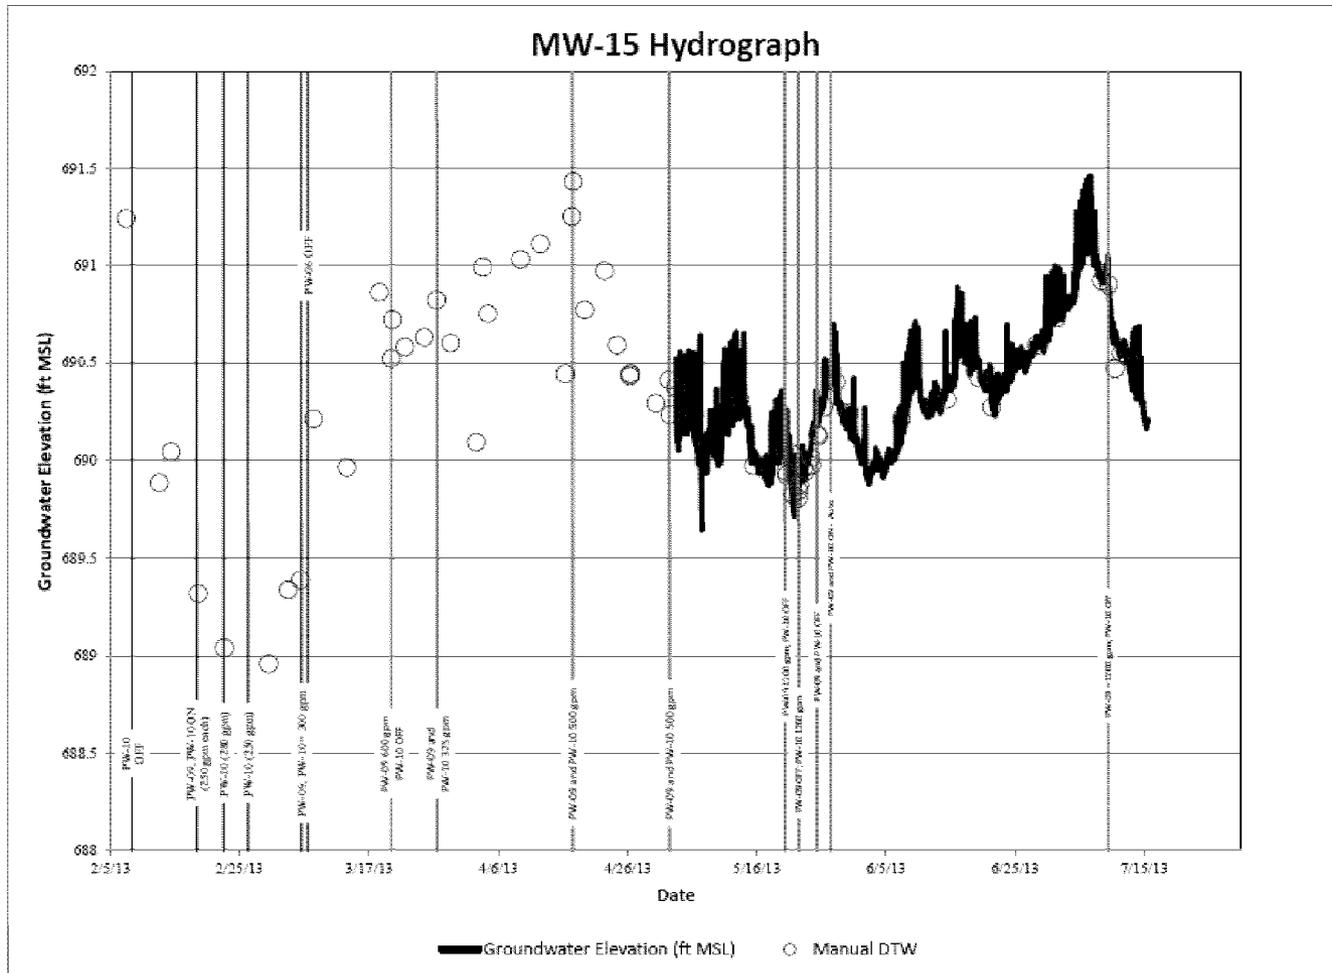
Cottage Grove Groundwater MW-15 Hydrograph

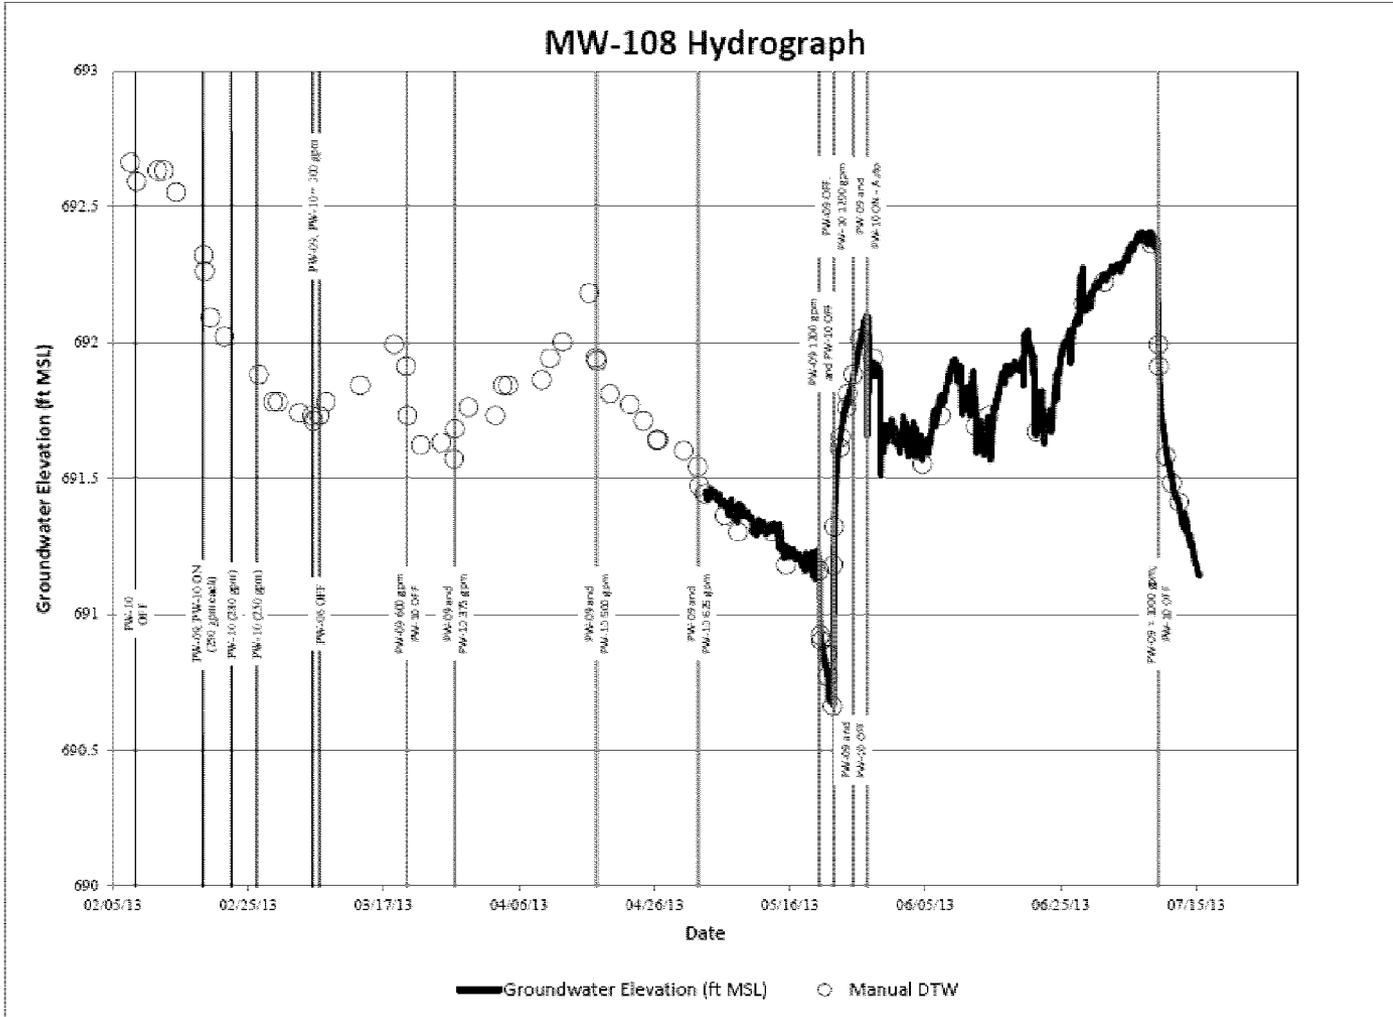
Cottage Grove Groundwater MW-108 Hydrograph

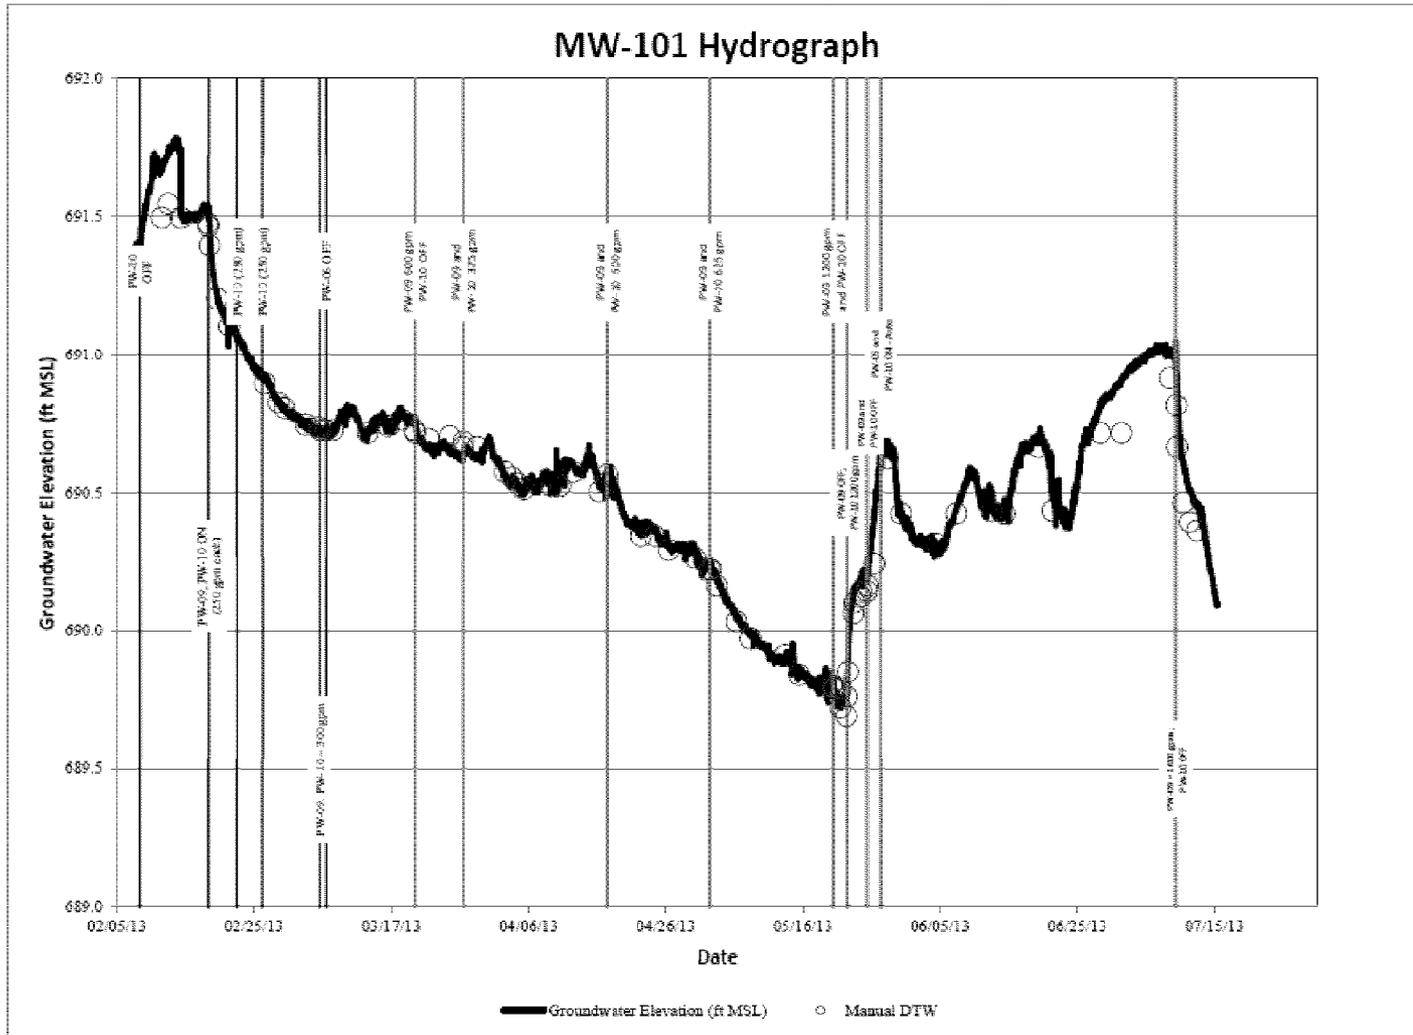
Cottage Grove Groundwater MW-101 Hydrograph
