Status of the PFC Assessment/Remediation Projects in Minnesota

Presented to: MPCA
St. Paul, MN

Presented by: 3M Company

Date: July 23, 2013

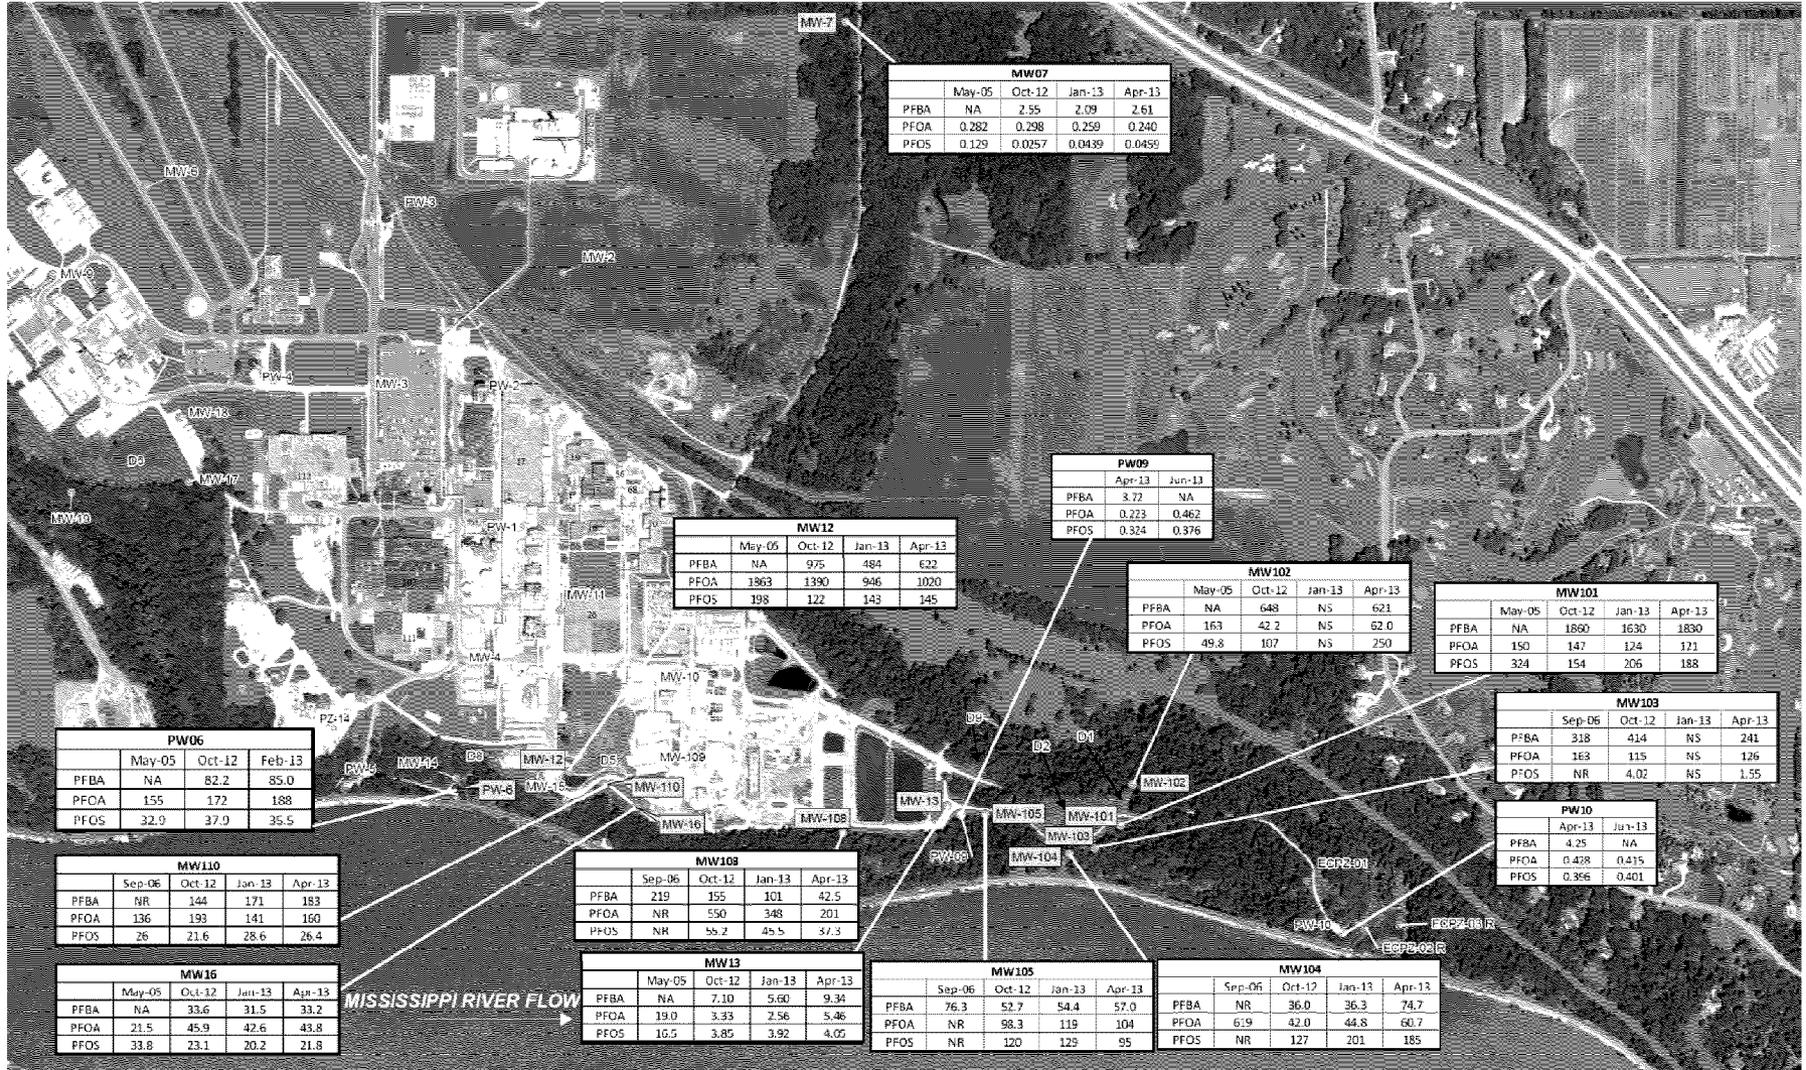
Cottage Grove PFC Groundwater Concentrations (ug/L, ppb)

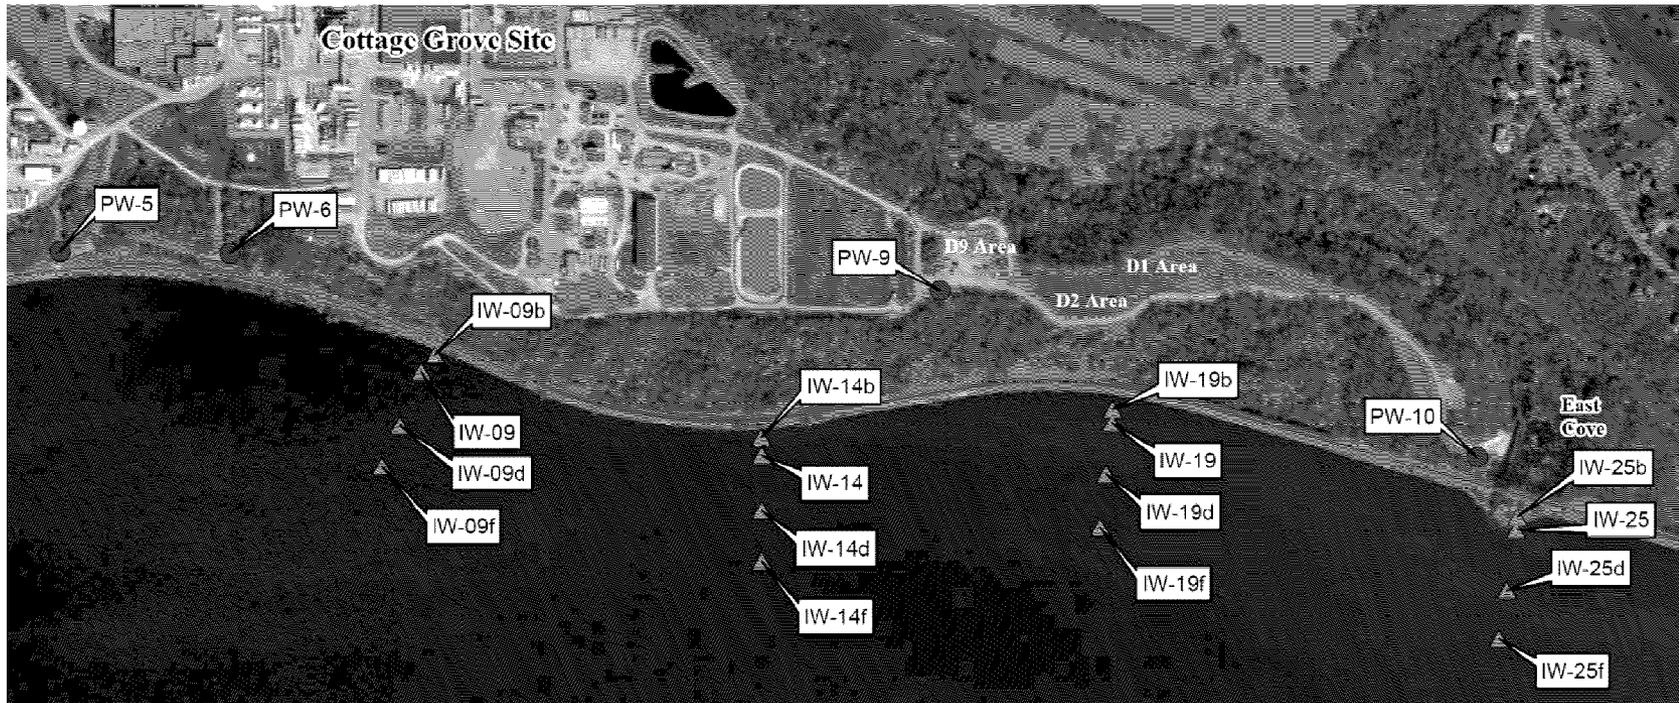
Cottage Grove Surface Water and Pore Water Sampling (cont.)

- Pore water concentrations are higher than surface water concentrations
- Locations closer to shore generally have higher pore water concentrations than those further out in the river
- June 2011 had generally the lowest surface water levels. Higher concentrations observed in October 2012
- The surface water location directly downstream of the plant discharge (IW-25) had generally higher concentrations than the upstream locations

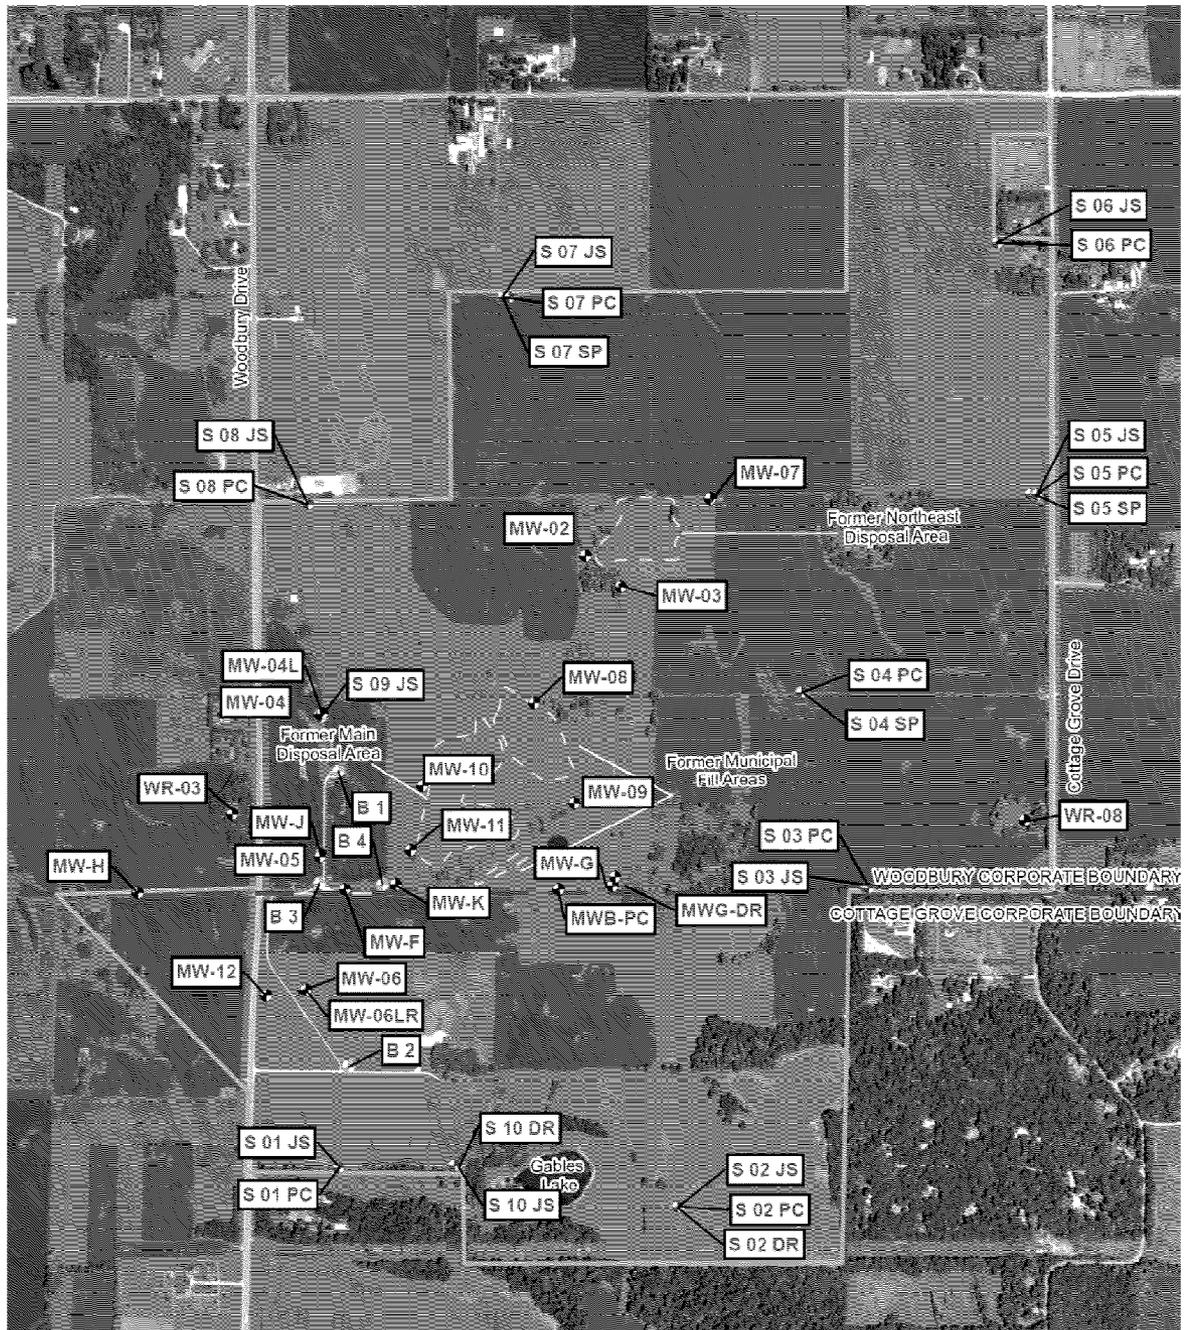
Monitoring Well Trends

- June results were consistent or less than previous samples
- PFOA and PFOS concentrations decreased in MW 2, downgradient of Northeast Disposal Area and in SO6PC.
- Groundwater elevation data continue to show groundwater capture is being maintained.

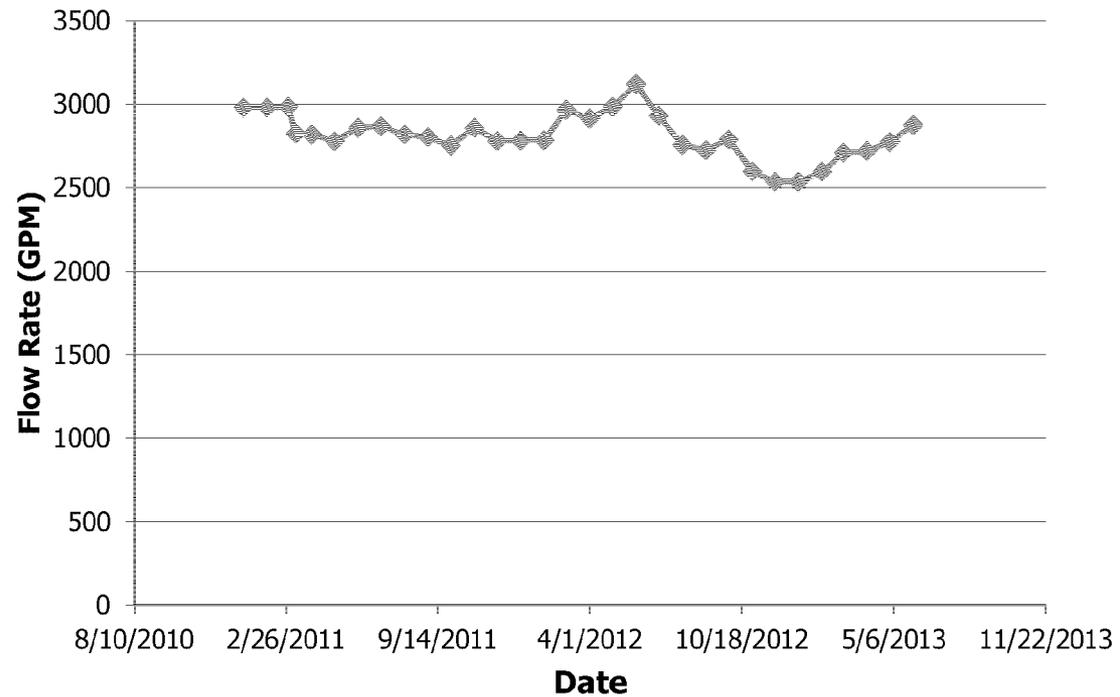
Barrier Well Flow Data

Barrier Well Combined Flow Rate

- Minor variations in flow rates have occurred historically and have decreased since Woodbury has been connected to the new carbon treatment building at Cottage Grove.
- Groundwater elevation data collected over the past two years indicates that groundwater capture is maintained under all flow rate variations observed.

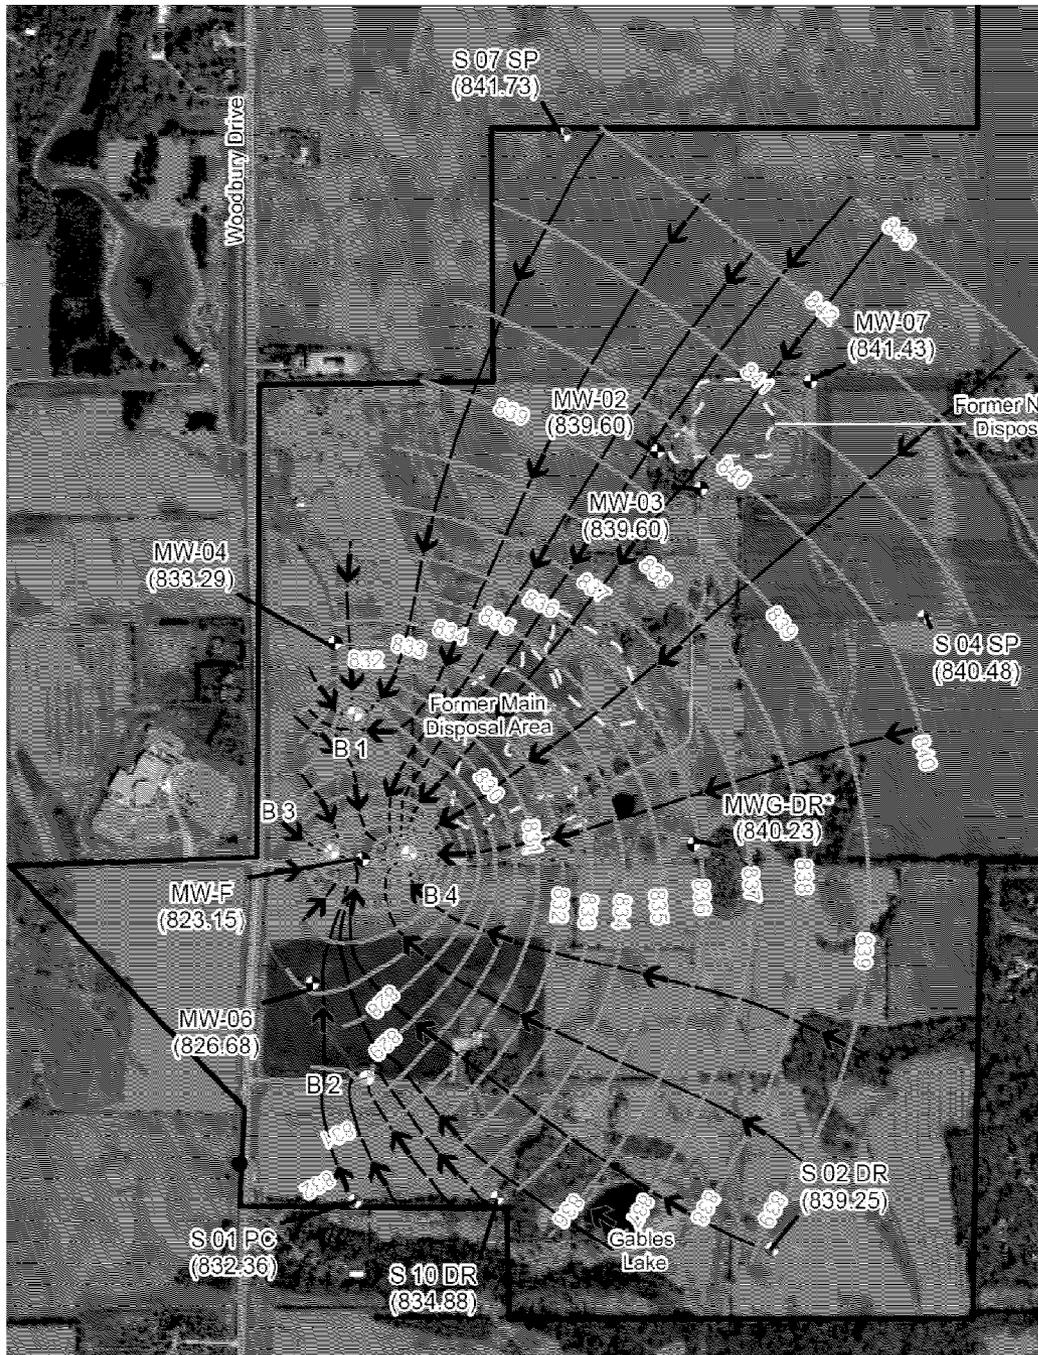
GROUNDWATER ELEVATION
 CONTOUR MAP
 SHALLOW WELLS-
 PUMPING CONDITIONS
 3 JANUARY 2013

WOODBURY SITE
 WOODBURY, MN

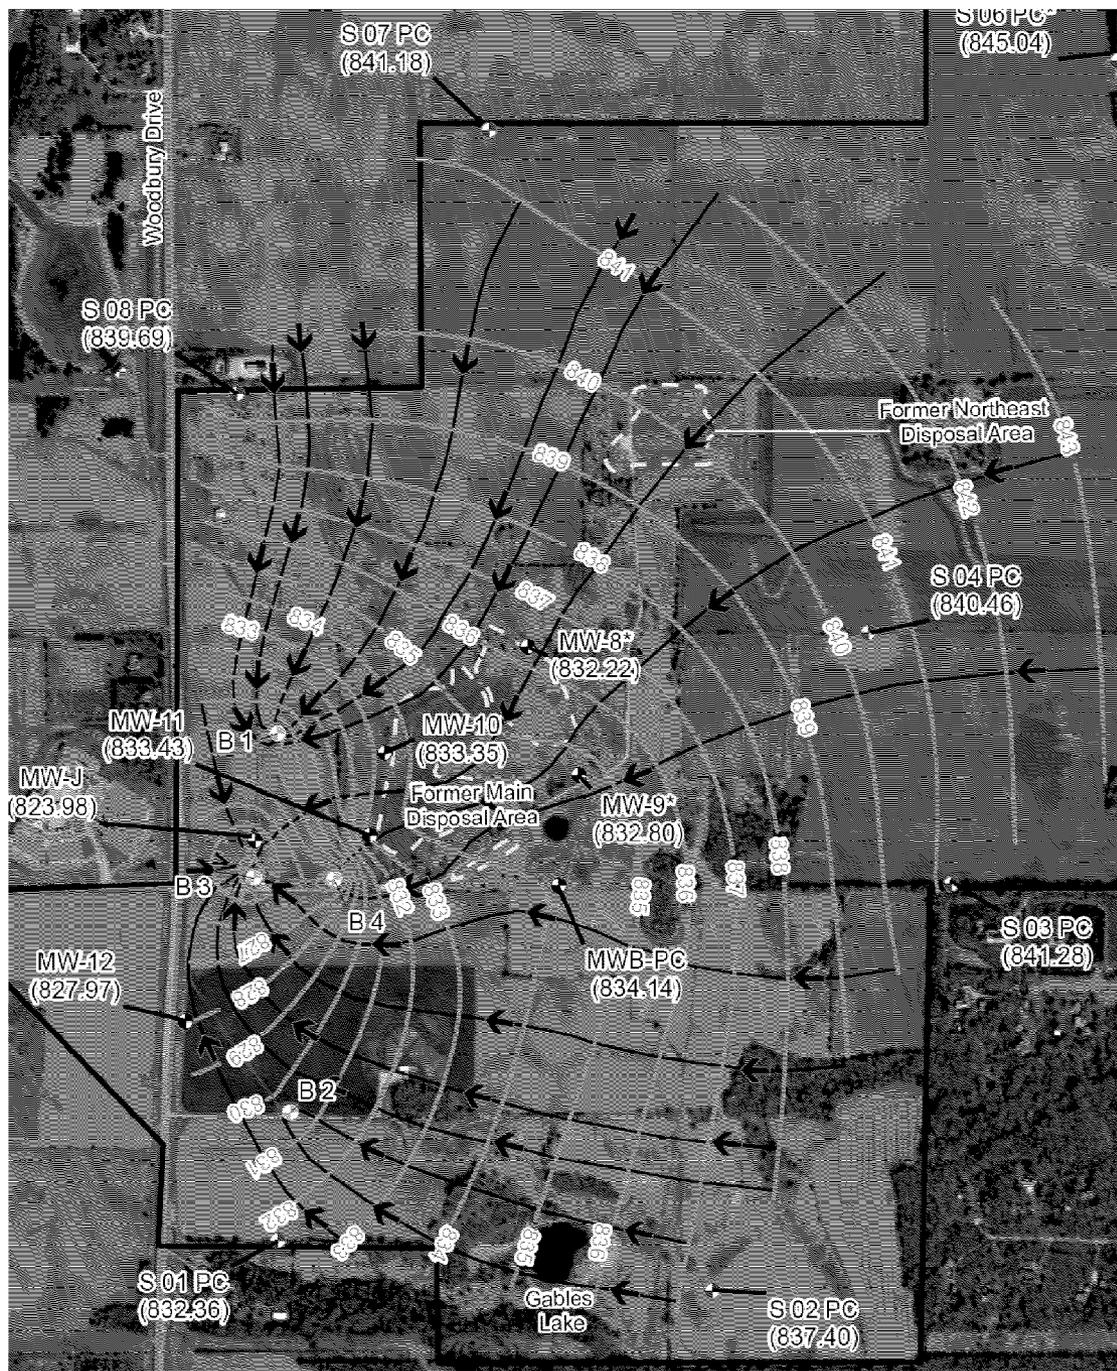
GROUNDWATER ELEVATION
 CONTOUR MAP
 SHALLOW PRAIRIE DU CHIEN WELLS
 PUMPING CONDITIONS
 03 JANUARY 2013

3M WOODBURY SITE
 WOODBURY, MN

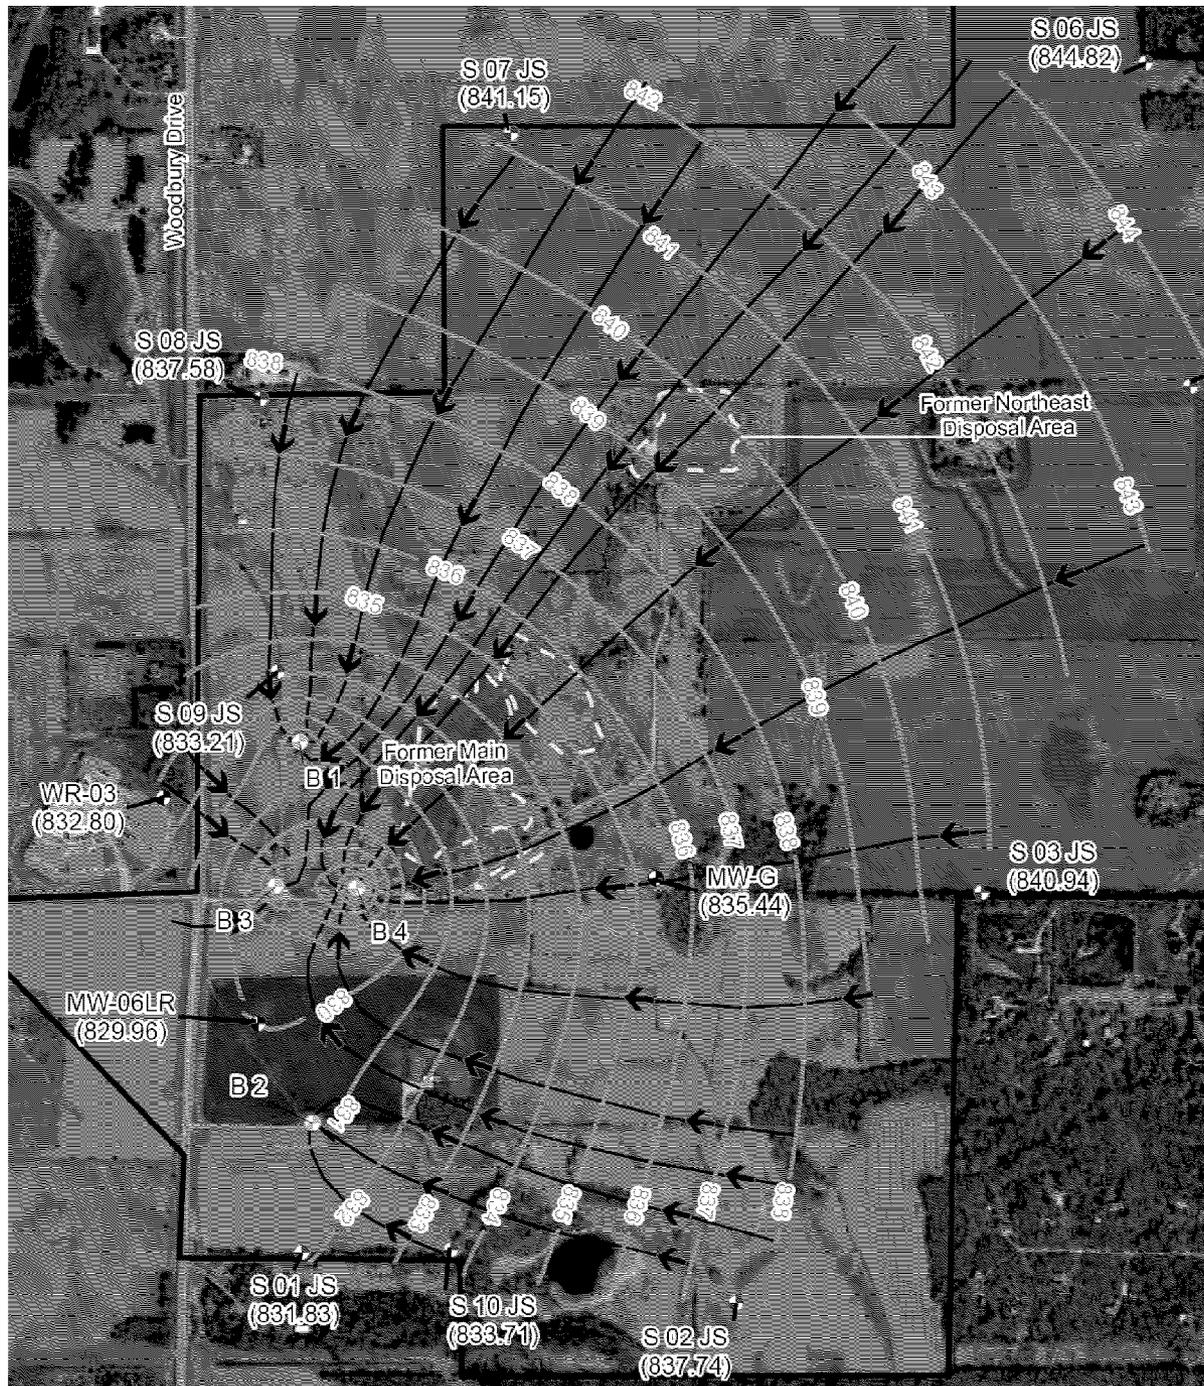
GROUNDWATER ELEVATION
 CONTOUR MAP
 JORDAN SS MONITOR WELLS-
 PUMPING CONDITIONS
 03 JANUARY 2013

3M WOODBURY SITE
 WOODBURY, MN

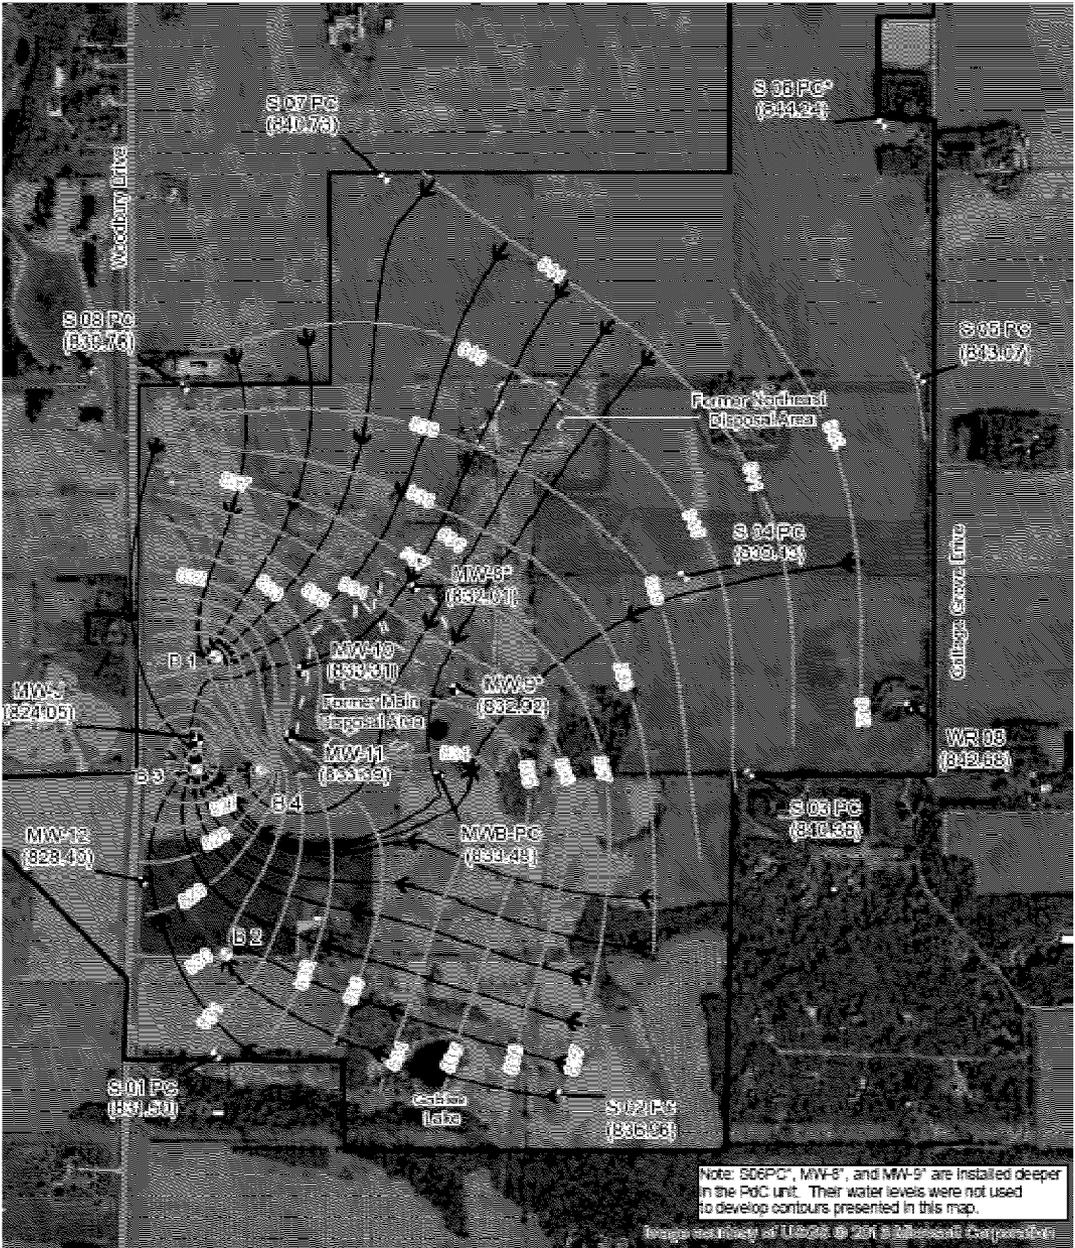
GROUNDWATER ELEVATION
 CONTOUR MAP
 SHALLOW PRAIRIE DU CHIEN WELLS
 PUMPING CONDITIONS
 4 JUNE 2013

3M WOODBURY SITE
 WOODBURY, MN

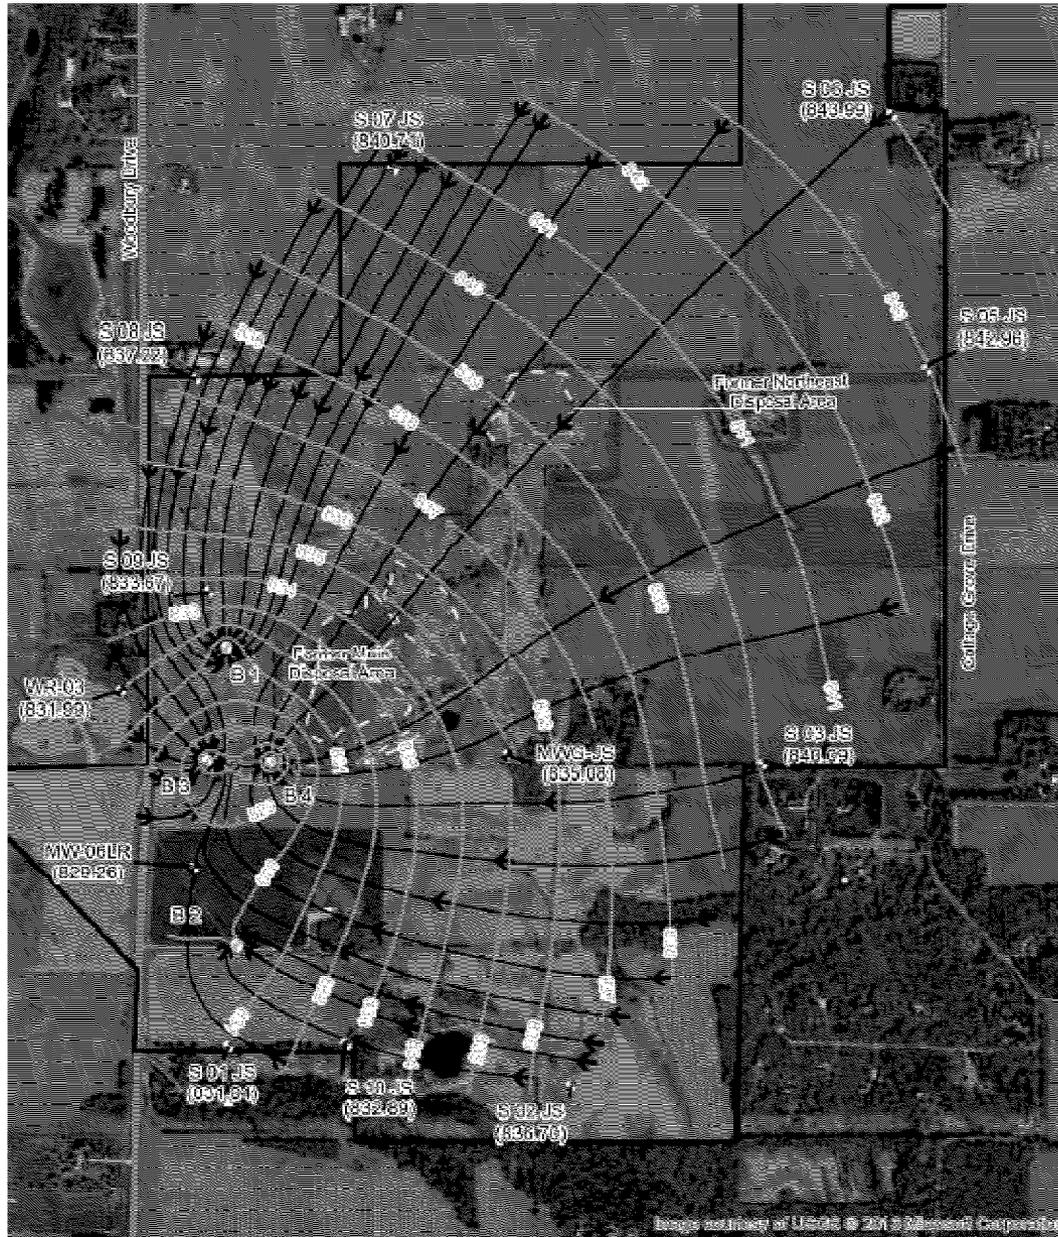
GROUNDWATER ELEVATION
 CONTOUR MAP
 JORDAN SS MONITOR WELLS-
 PUMPING CONDITIONS
 4 JUNE 2013

3M WOODBURY SITE
 WOODBURY, MN
